# **Asteroom Property Data Collection**

1. Information		
File #	Case File ID	Property Type
PDC_160	88888888	Single Family
Occupancy	Lock Box	Quality of Construction Rating
Yes	No	Q2
Condition Rating	Repair Estimate	
C2	0	
	0	
Address		
	0 Property Street Address (unit #)	Property City
Address		Property City Tigard
Address Property Street Address

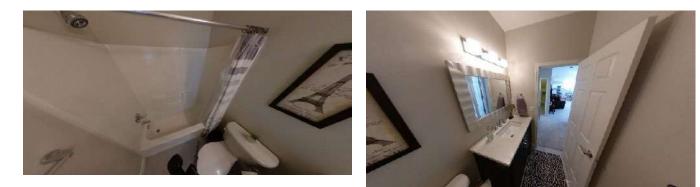
#### Additional Photos

Bathroom 2

None Observed

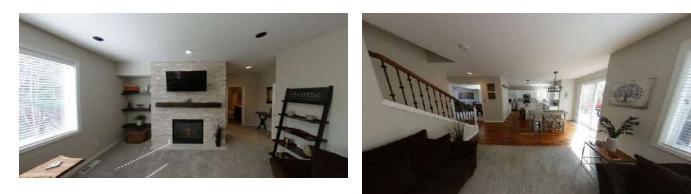
#### Additional Photos

## Family Room

None Observed

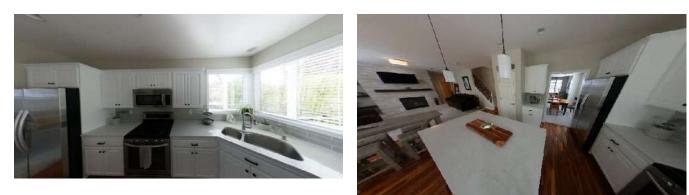
#### Additional Photos

Update Type	Timeframe	Description
Replaced	2-5	Entire Kitchen remodeled in 2019

Entire Kitchen remodeled in 2019 with new appliances

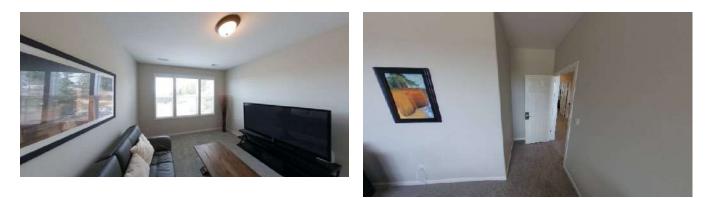
#### Additional Photos

## Bedroom 6

None Observed

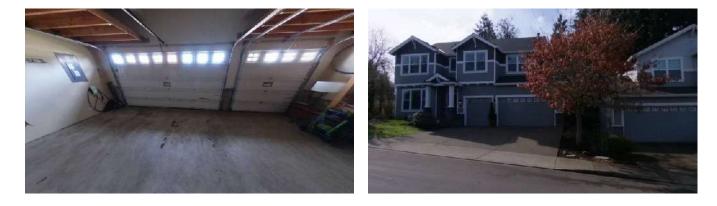
#### Photo(s)

Туре	Count	SQFT	
Attached Garage	3	565	
Garage Conversion

None Observed
