Completed On: 03/09/2023

Property Street Address:	
Property City:	Kissimmee
Property State:	FL
Property Zip Code:	34746
Property County:	Osceola County
Borrower Name:	
Lender Name:	
Lender Address:	
Lender Contact Information:	Erika@actappraisal.com
AMC Name:	ACT Appraisal, Inc
Assignment Type:	Refinance
PDR Type:	ACE+PDR
Data Set Version:	2.0
Property Type:	SFD
LPA Key:	N/A
Seller Identifier:	
File #:	308318
Additional File #:	308318
Sales Contract Amount:	
Sales Contract Date:

Property Photos

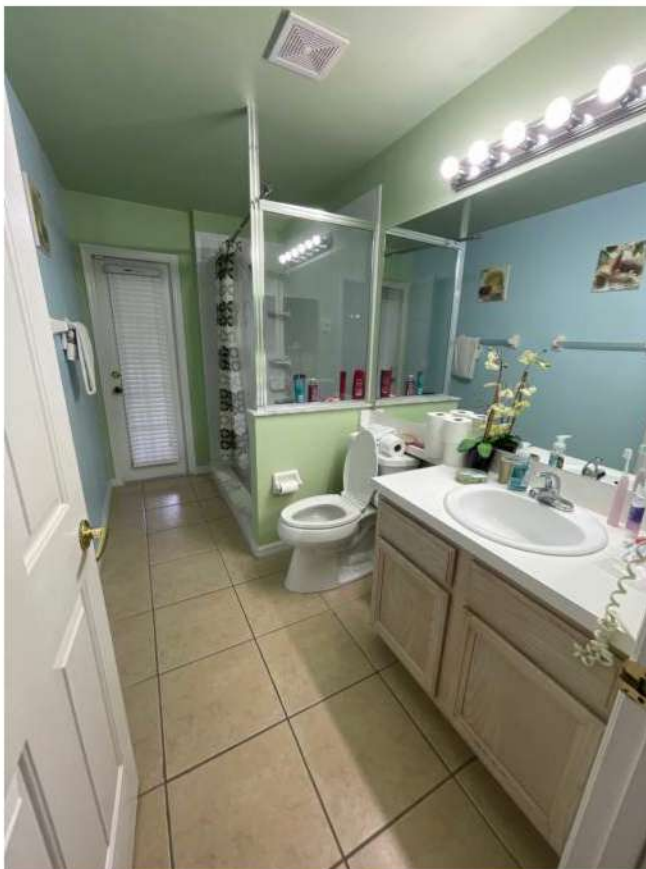
Bathroom Full 1

Floor Condition: None

Wall Condition: None

Shower/Tub Condition: None

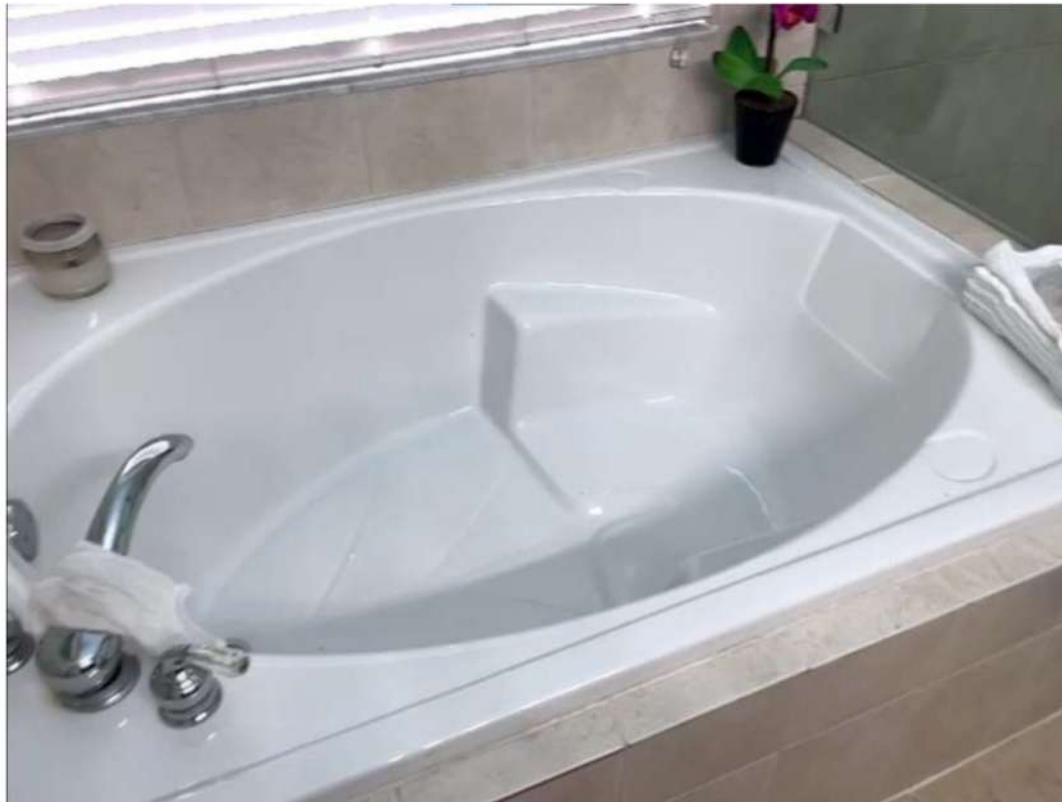
Bathroom Master

Level: 1
Floor Type: Tile
Floor Condition: None
Floor Update: No Update
Floor Update Description:
Wall Type: Drywall
Wall Condition: None
Wall Update: No Update
Wall Update Description:
Upgrades with Last 15 Years: Unknown
Upgrades Description:
Plumbing Fixtures: Bath Tub, Shower, Double Sink, Toilet
Bathroom Countertops: Stone Or Equivalent
Bathroom Cabinets: Standard Typical
Shower/Tub Surround Material: Tile
Shower/Tub Condition: None

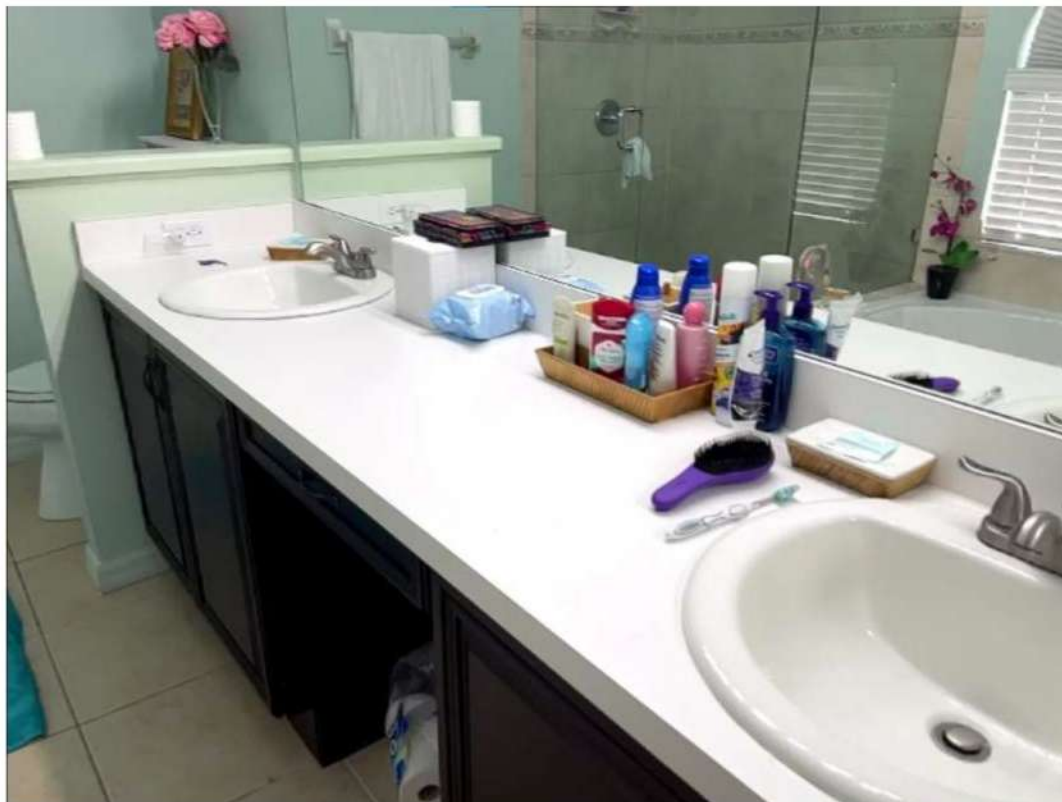
Bathroom Master

Level: 1
Floor Type: Tile
Floor Condition: None
Floor Update: No Update
Floor Update Description:
Wall Type: Drywall
Wall Condition: None
Wall Update: No Update
Wall Update Description:
Upgrades with Last 15 Years: Unknown
Upgrades Description:
Plumbing Fixtures: Double Sink, Toilet, Shower, Bath Tub
Bathroom Countertops: Stone Or Equivalent
Bathroom Cabinets: Standard Typical
Shower/Tub Surround Material: Tile
Shower/Tub Condition: None

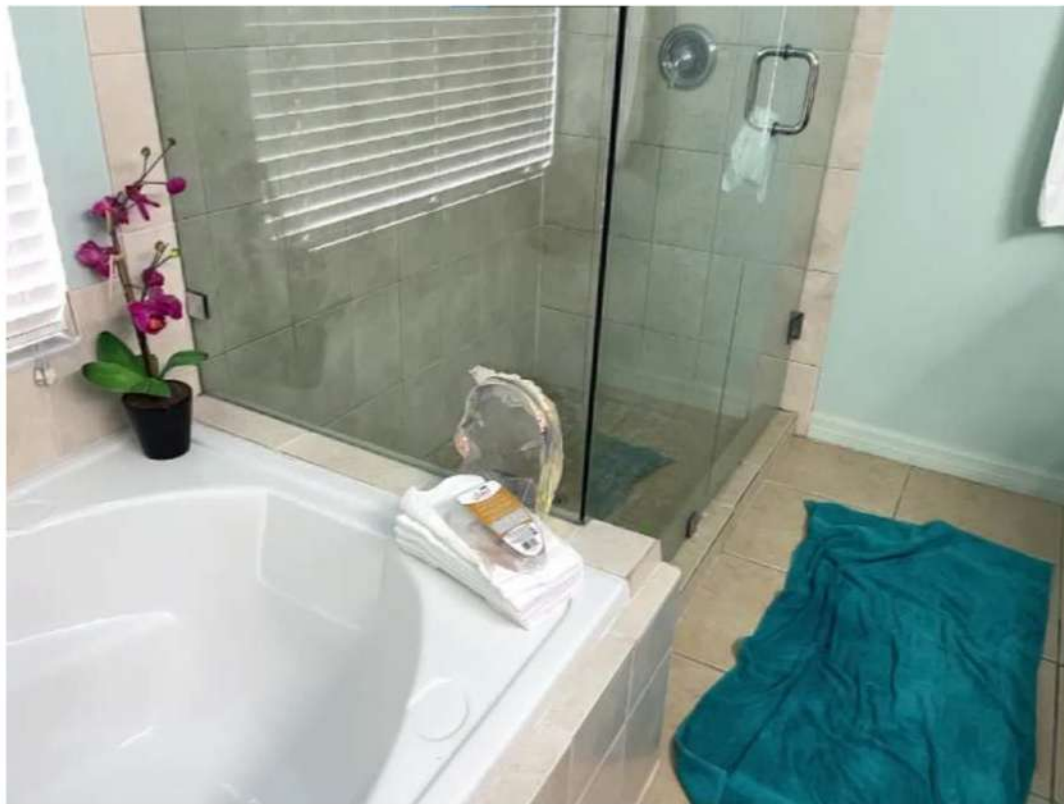
Bathroom Master

Floor Condition: None

Wall Condition: None

Shower/Tub Condition: None

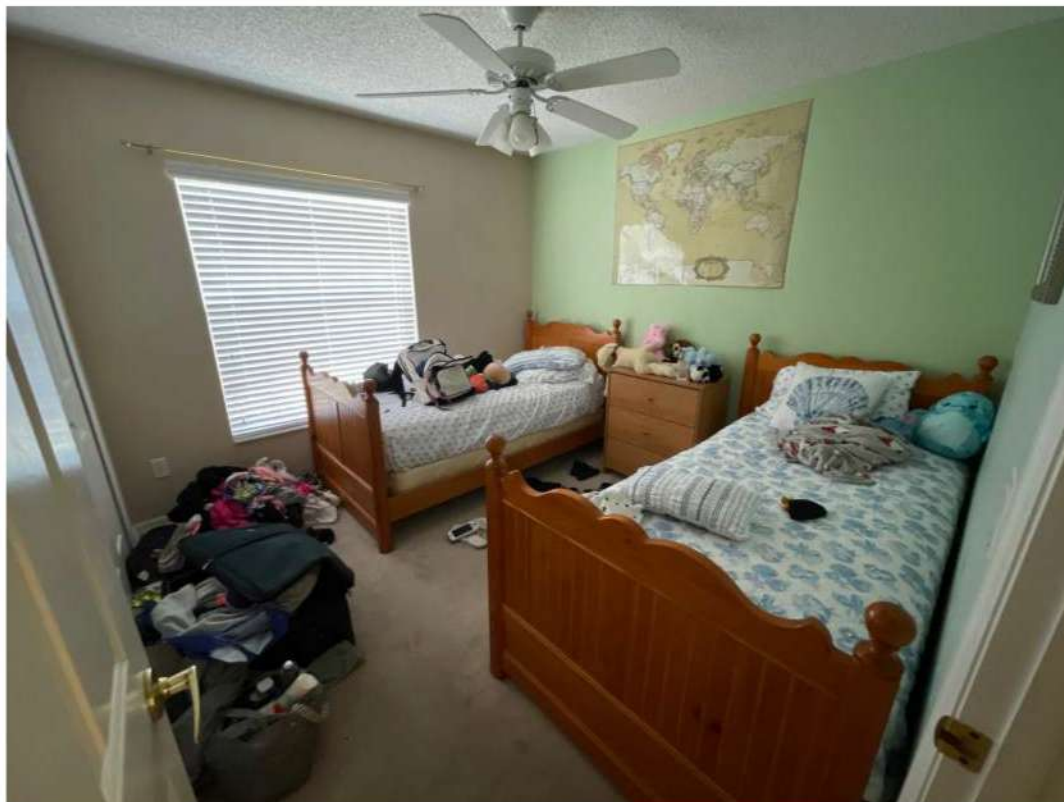
Bedroom 1

Floor Condition: None

Wall Condition: None

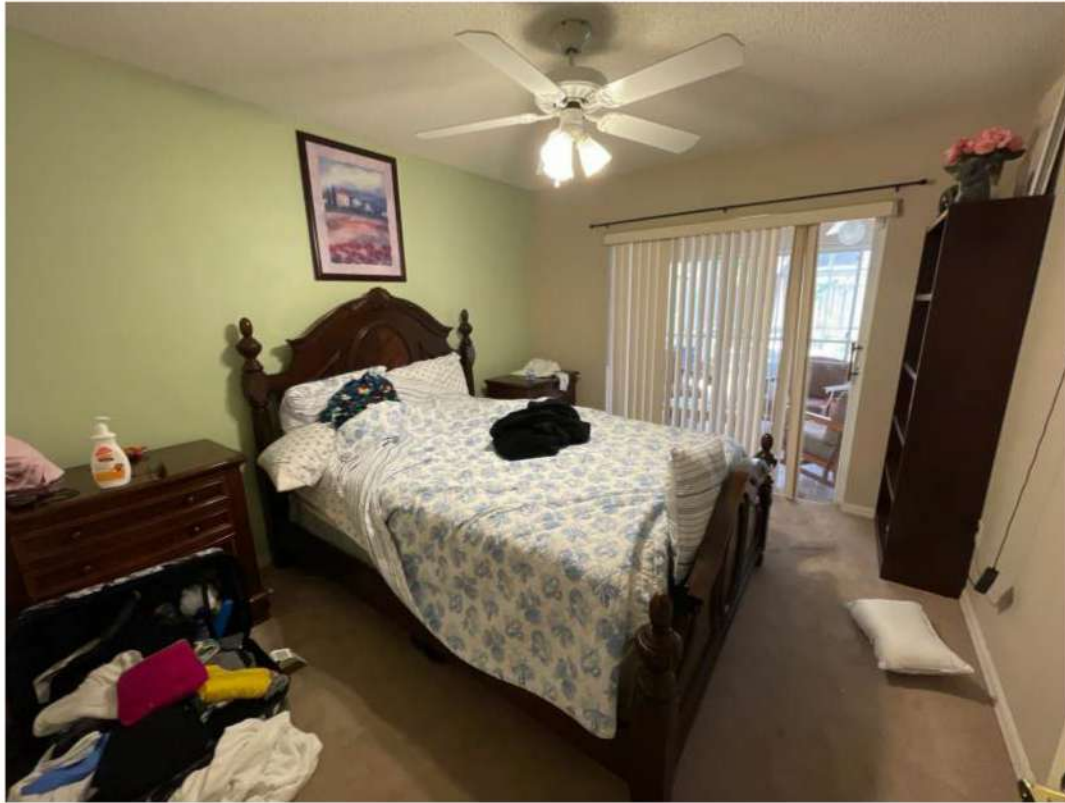
Bedroom 2

Level: 1
Floor Type: Carpet
Floor Condition: None
Floor Update: No Update
Floor Update Description:
Wall Type: Drywall
Wall Condition: None
Wall Update: No Update
Wall Update Description:

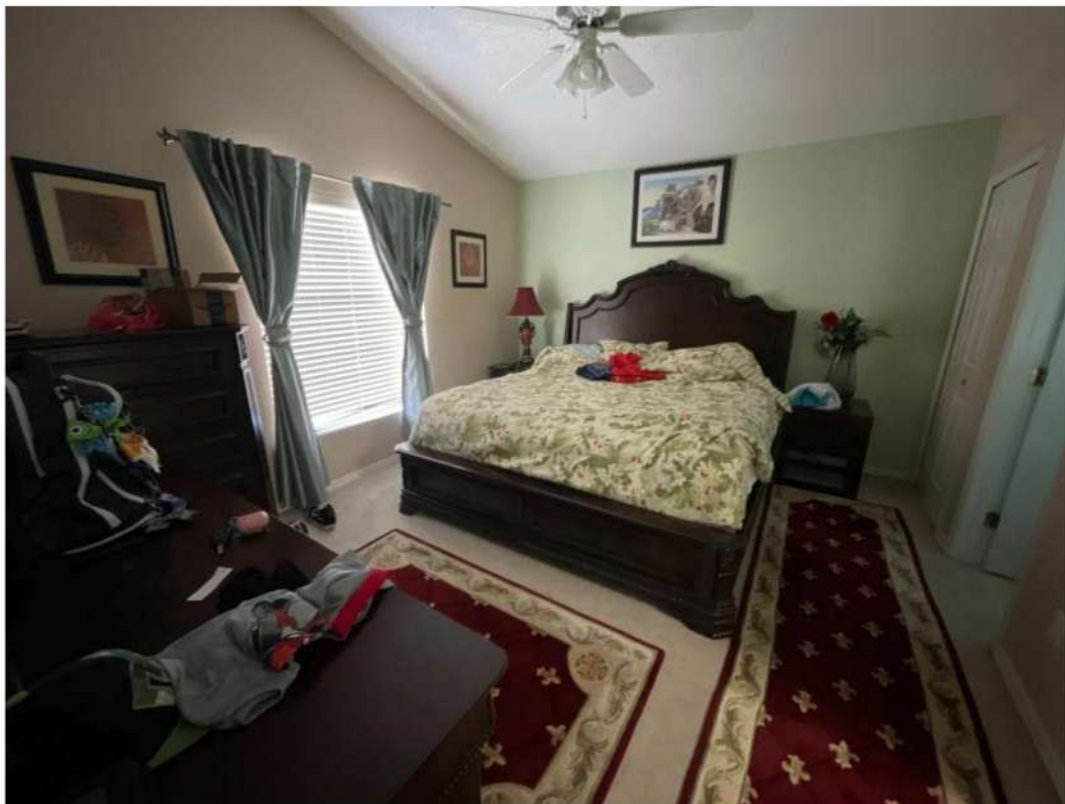
Bedroom Master

Level: 1
Floor Type: Carpet
Floor Condition: None
Floor Update: No Update
Floor Update Description:
Wall Type: Drywall
Wall Condition: None
Wall Update: No Update
Wall Update Description:

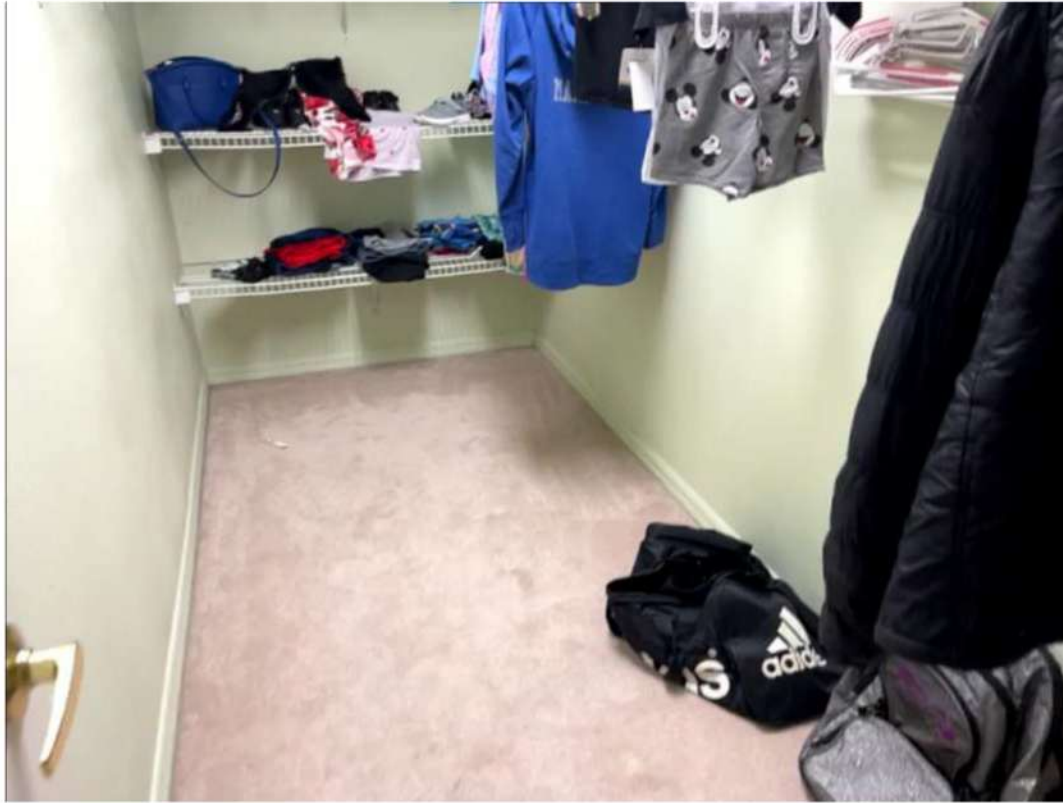
Bedroom Master Walk-In Closet

Floor Condition: None

Wall Condition: None

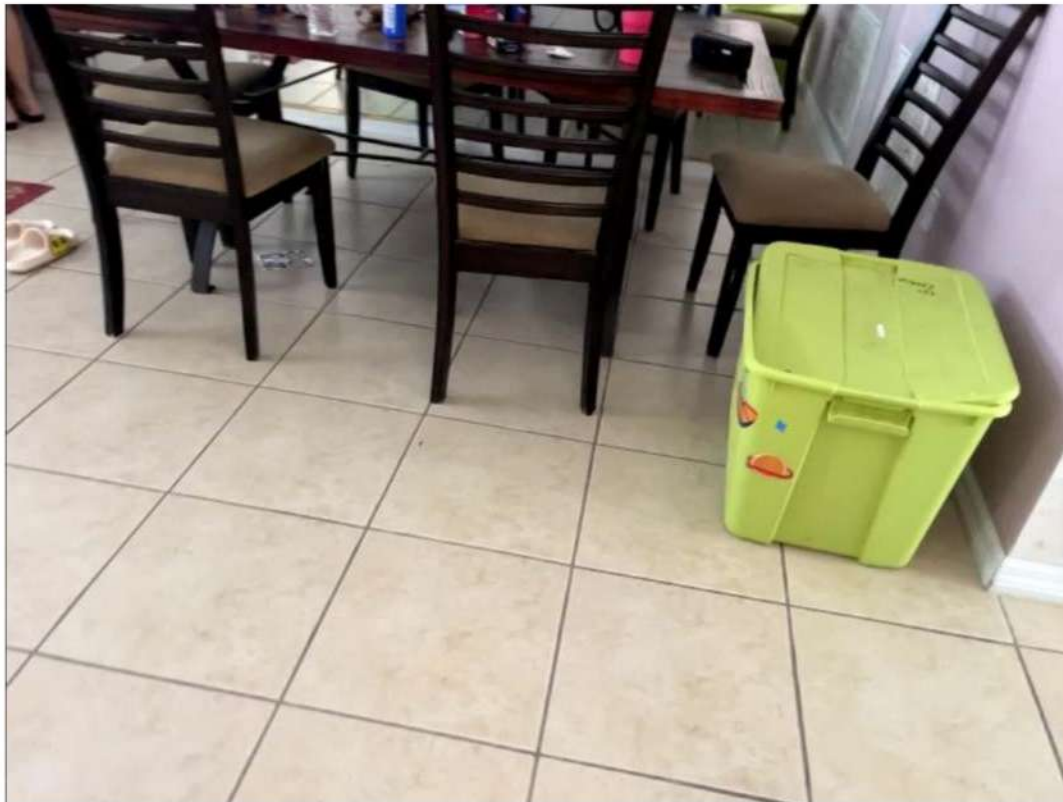
Dining Room

Floor Condition: None

Wall Condition: None

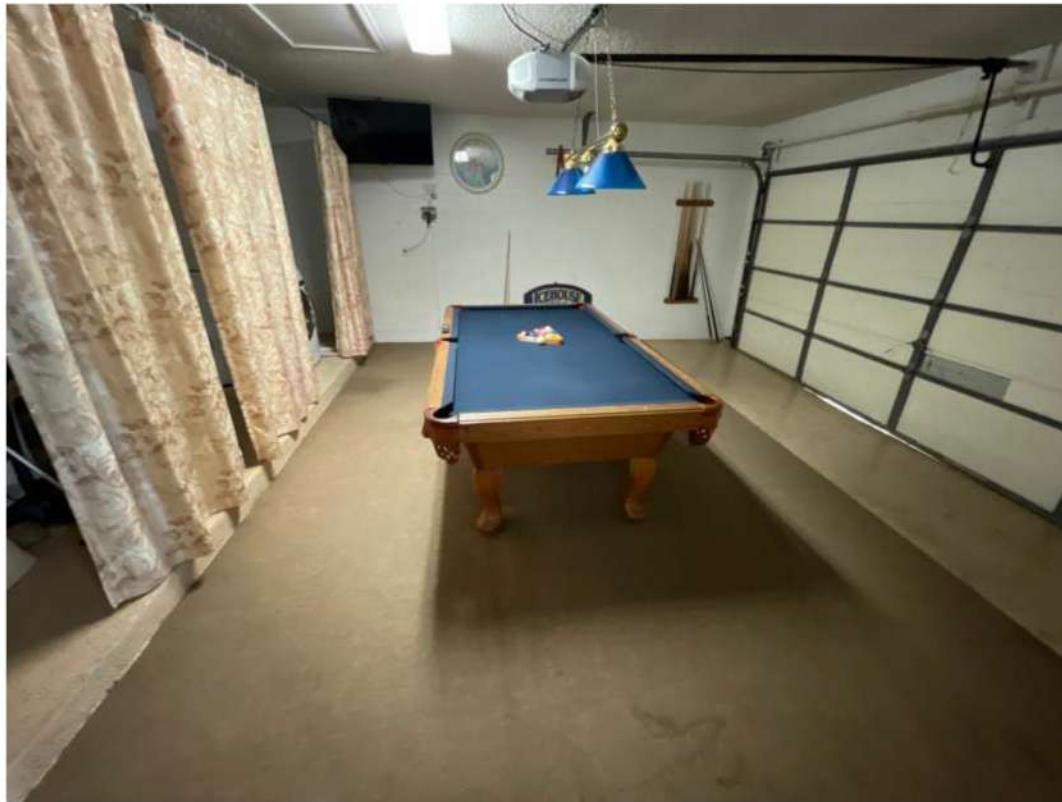
Garage

Level: 1
Floor Type: Finished Concrete
Floor Condition: None
Floor Update: No Update
Floor Update Description:
Wall Type: Drywall
Wall Condition: None
Wall Update: No Update
Wall Update Description:

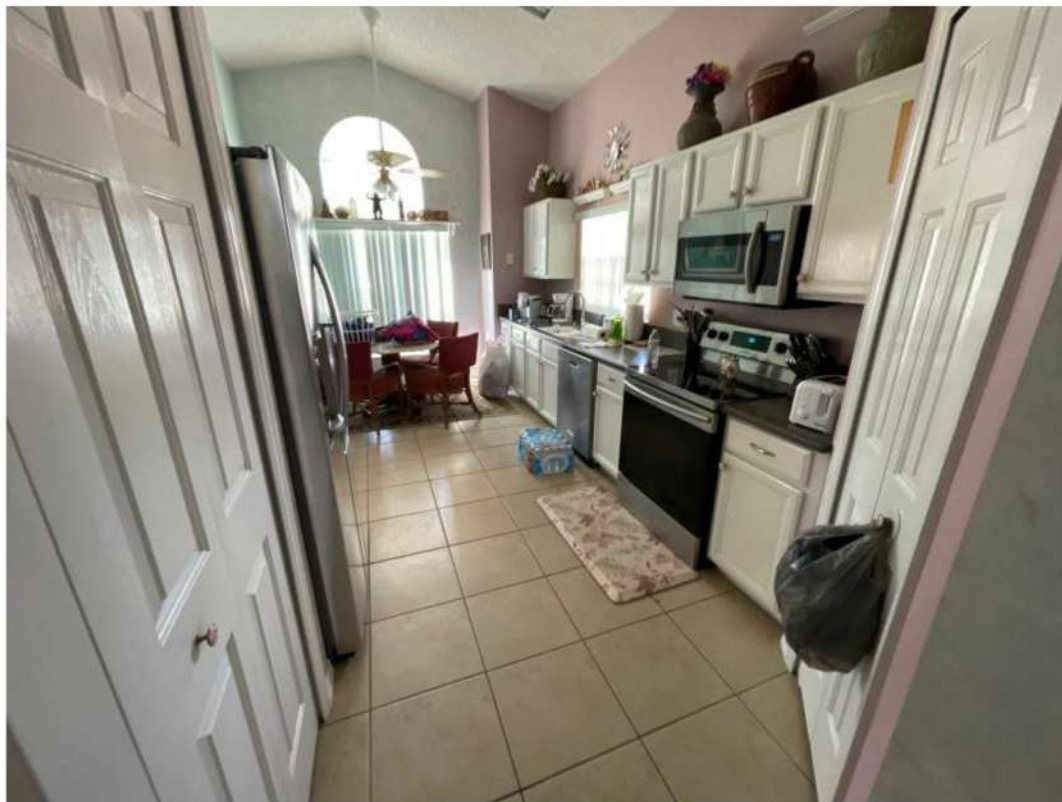
Kitchen / Breakfast Nook

Level: 1
Floor Type: Tile
Floor Condition: None
Floor Update: No Update
Floor Update Description:
Wall Type: Drywall
Wall Condition: None
Wall Update: No Update
Wall Update Description:
Appliances: Refrigerator, Range
Oven, Dishwasher, Microwave,
Disposal
Appliance Other:
Kitchen Countertops: Stone Or
Equivalent
Kitchen Cabinets: Standard Typical
Upgrades with Last 15 Years: Not
Updated
Upgrades Description:

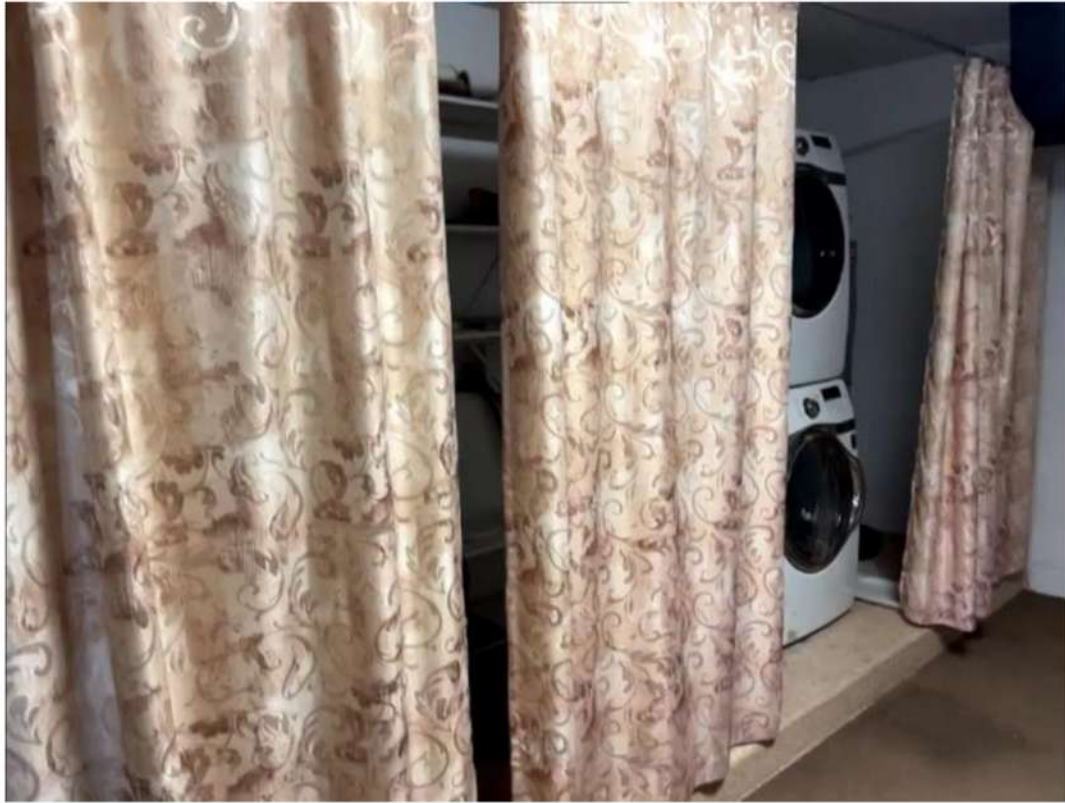
Laundry Area

Level: 1
Floor Type: Unfinished Concrete
Floor Condition: None
Floor Update: No Update
Floor Update Description:
Wall Type: Drywall
Wall Condition: None
Wall Update: No Update
Wall Update Description:
Washer/Dryer Hookup?: Yes

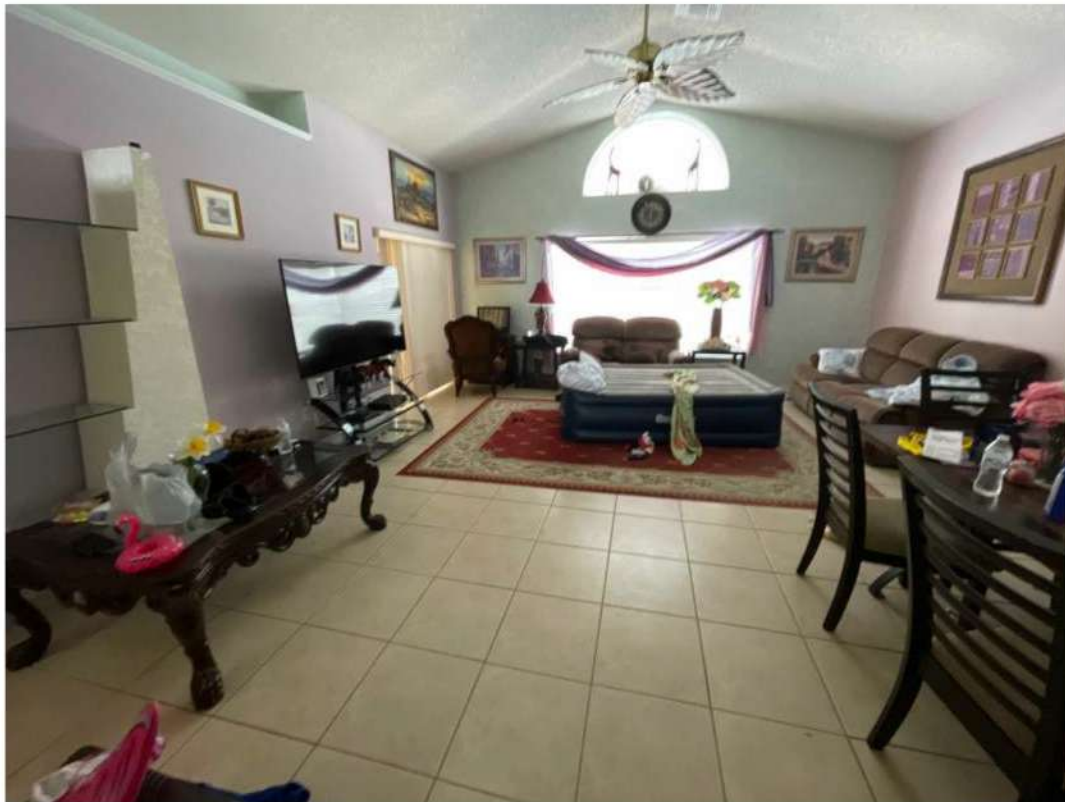
Living Room / Dining Room

Level: 1
Floor Type: Tile
Floor Condition: None
Floor Update: No Update
Floor Update Description:
Wall Type: Drywall
Wall Condition: None
Wall Update: No Update
Wall Update Description:

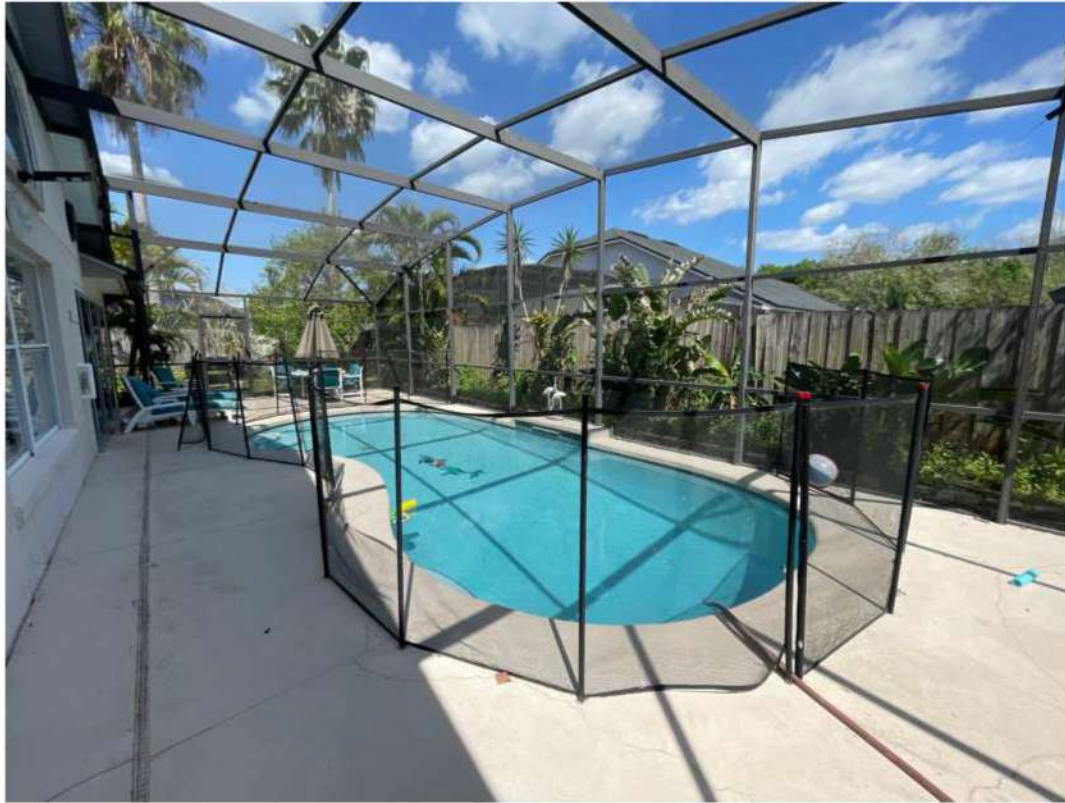
Pool

Floor Condition: None

Wall Condition: None

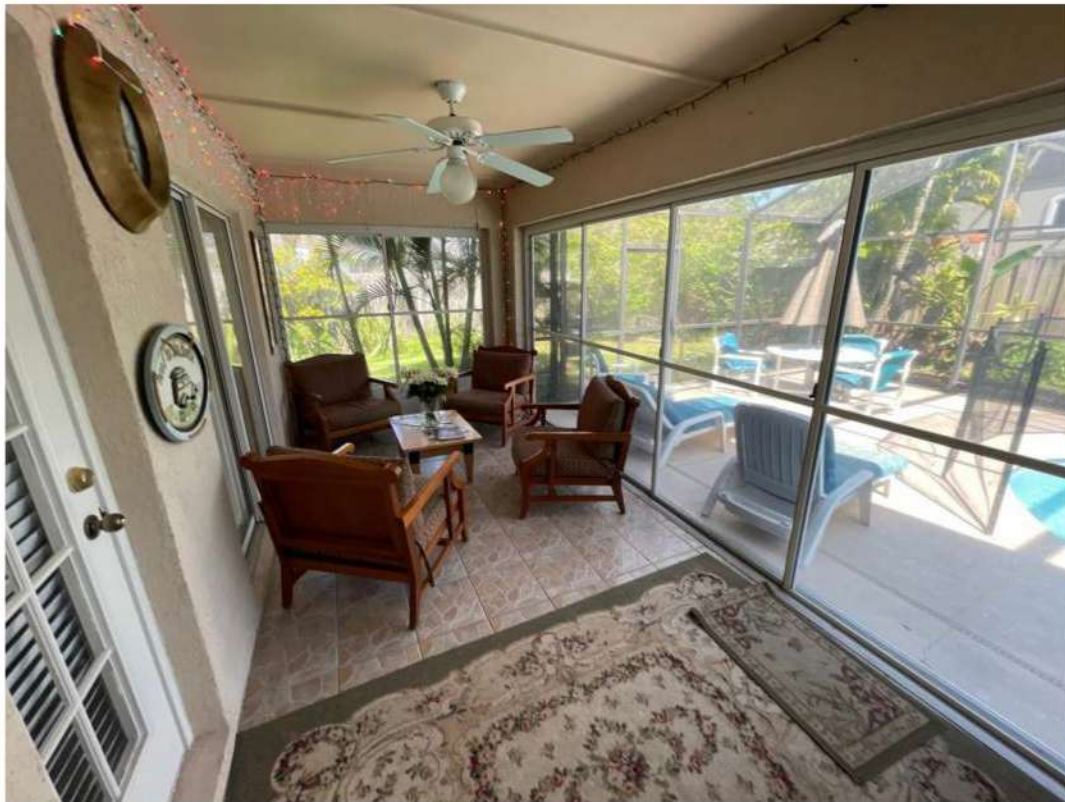
Screened Patio

Floor Condition: None

Wall Condition: None
